Navajo Abandoned Uranium Mine

Site Screen Report

Charles Huskon No. 18 AUM Site

January 2011

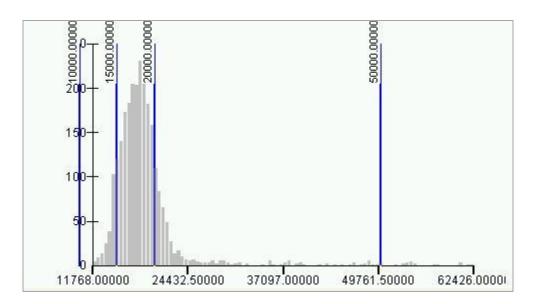
Distribution Chart and Statistics:

A total of 2,490 gamma radiation measurements were collected from the mine site, ranging from 11,768 cpm to 62,426 cpm. The measurements are represented in Figures 1 and 2.

The following chart and statistics were generated by ESRI ArcGIS 9.3.1, and show the general distribution of the site gamma radiation measurements. The horizontal X axis represents the gamma radiation reading levels in cpm (lowest levels to the left). The vertical Y axis represents the frequency of each gamma radiation level.

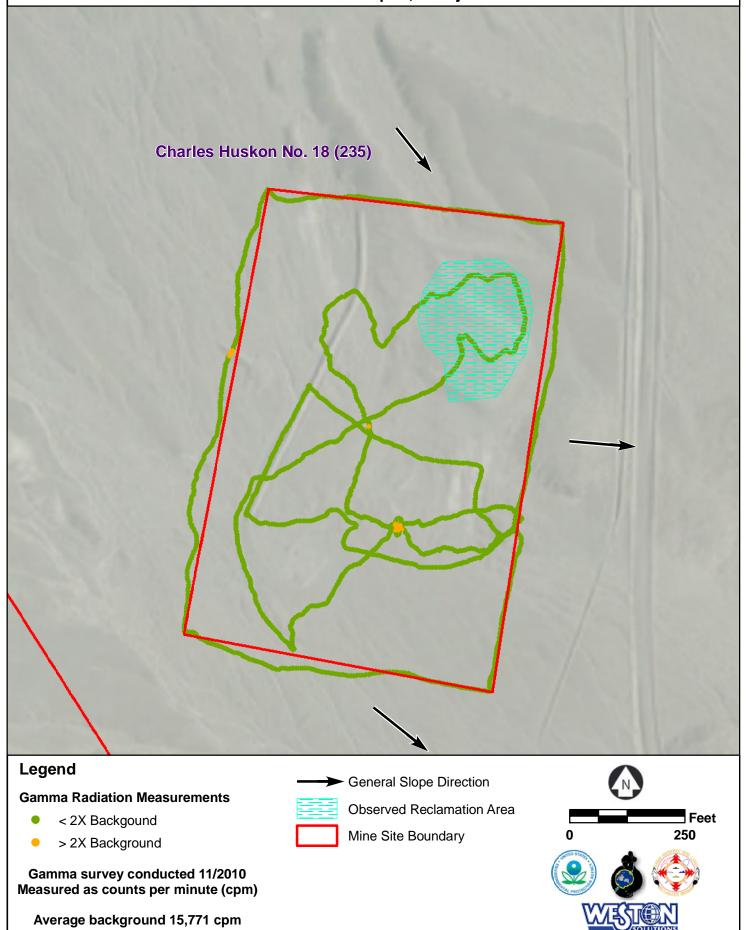
Figure 1 - Gamma Radiation Measurements, Above Two Times Background
Charles Huskon No. 18 (235)
Coalmine Mesa Chapter, Navajo Nation

Were any gamma radiation measurements collected at the mine greater than two times the site-specific background levels?

Yes

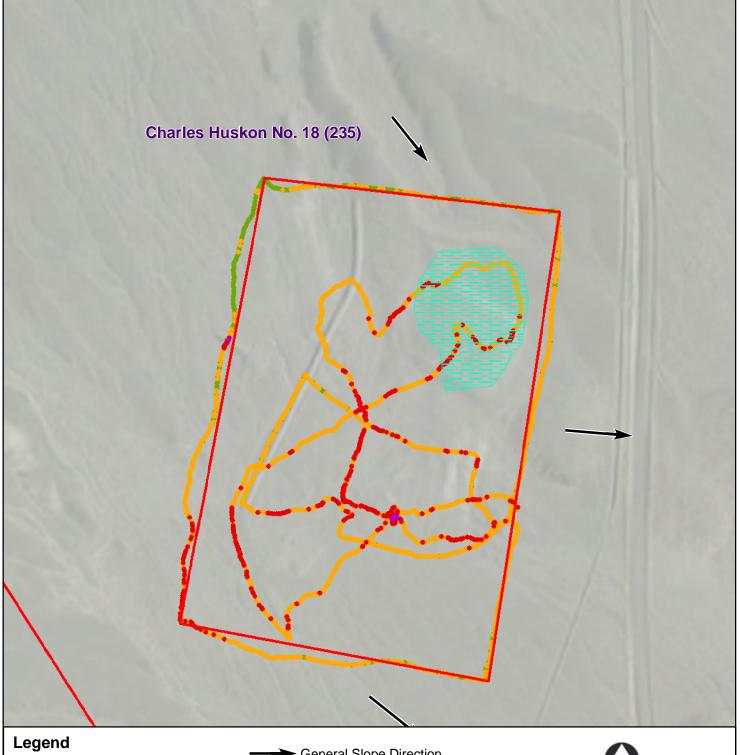
Figure 2 - Gamma Radiation Measurements Charles Huskon No. 18 (235) Coalmine Mesa Chapter, Navajo Nation

Gamma survey conducted 11/2010 Measured as counts per minute (cpm)

Average background 15,771 cpm
